A Batter test solution for LIB Jelly-roll Insulation Test v1.4

Product Marketing VP
Bobby Tseng, 2018/09/03

Chroma ATE Inc.

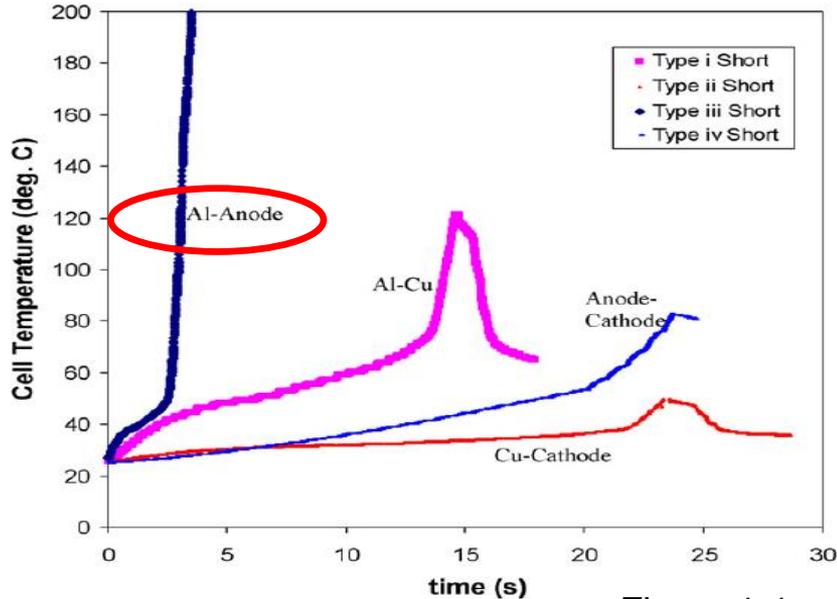
Figure 1-1

Figure 1-1: Four different kinds of ISC conditions of the LIB cell, and the temperature rising it may cause in the nearby area.

Type i, Short occurred between the positive electrode (Al) and negative electrode (Cu).

Type ii, between the negative electrode (Cu) and the coating of the positive electrode.

Type iii, between the coatings of the positive electrode and the negative electrode.

Type iv, between the positive electrode (Al) and the coating of the negative electrode.

Note : Type i – distributed in large area, low temperature rise and is not easy to reach cause fire. Type ii – carrier of positive electrode material is not electron, low conductivity. Type iv – same reason as Type ii. Type iii – very high energy concentrated on ultra small spot, very rapid temperature rise and could easily ignite the electrolyte (burning point of the electrolyte is about 230° Celsius)

As shown in figure 1-1, though all four conditions of the ISC lead to the battery failure, **yet the major cause to the burning or explosion of LIB cells is that the metal plate of the positive electrode (Al) shorts to the anode material**. Vast amount of charge transfer concentrated in a tiny locality in such short circuit condition would cause very rapid temperature rise and the ignition of a fire. The risk of a fire is depending on the heat generated in a localized tiny spot rather than the current magnitude of a short circuit, according to the experts of electrochemistry.

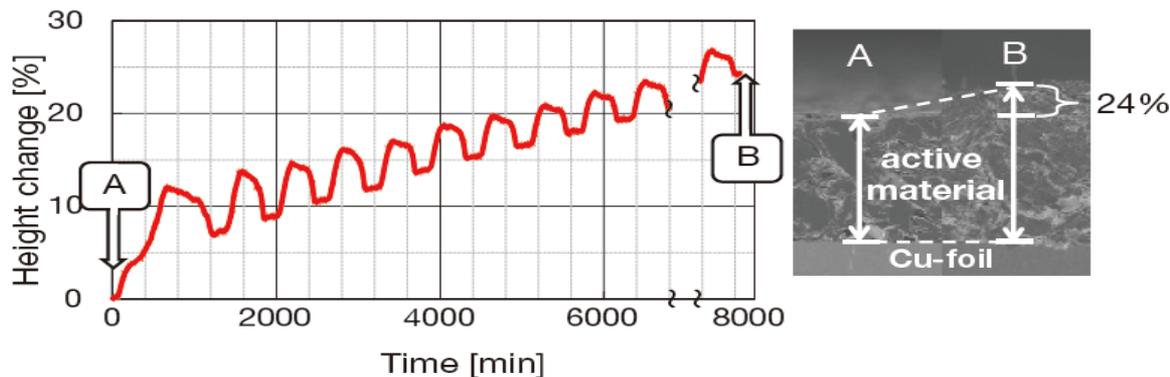
Figure 1-2: Changes of the thickness of the **graphite** material on the **negative** electrode of LIB during **repetitive charging/discharging cycles**. (According to the report no. 134 2015/1 from Furukawa Electric)

From figure 1-2, after around 10 charging/discharging cycles, **the graphite material on the negative electrode could inflate up to 24% more of its original thickness**. It is stated in the same report that: after the same number of charging/discharging cycles, **the silicon material on the same negative electrode would increase by even 110% more than the original**. This can explain why the LIB still get burned after even being sold to the end customers.

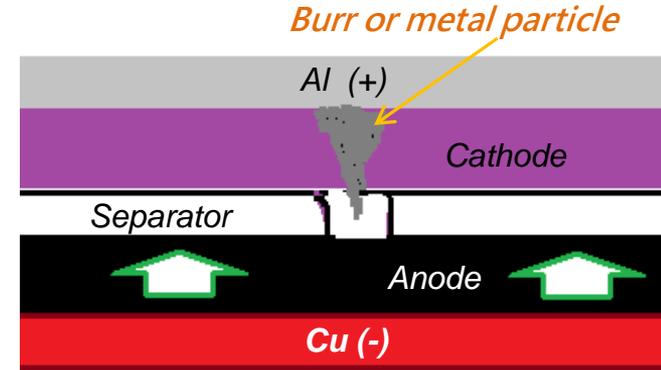
3. A more serious problem which is not known by most people: During a regular IR/Hi-Pot test on the dry cell of LIB, electrical discharge may happen on the burrs or metal impurities on the positive Al plate, and causes a melted hole in the separator, the electrical discharge may further cause the burrs shrunk so it won't be able to create the path for flashover anymore.

The result is this defective DUT passes most of the WV and IR tests. However, the melted hole and the burr is still there and is a big hazard to the safety. It could cause fire in the field if the anode material touch the burrs in further charging processes.

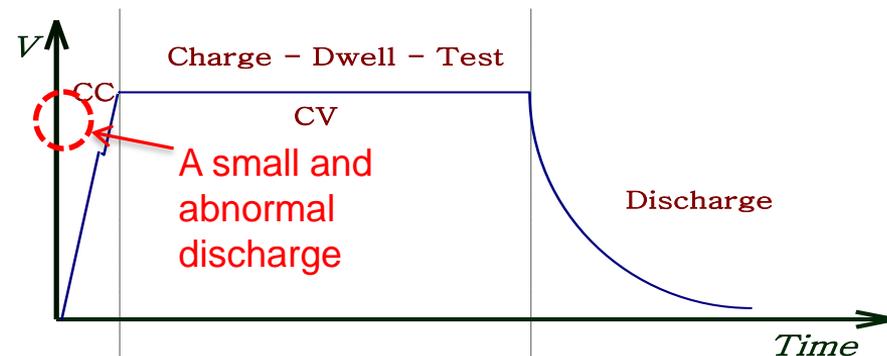
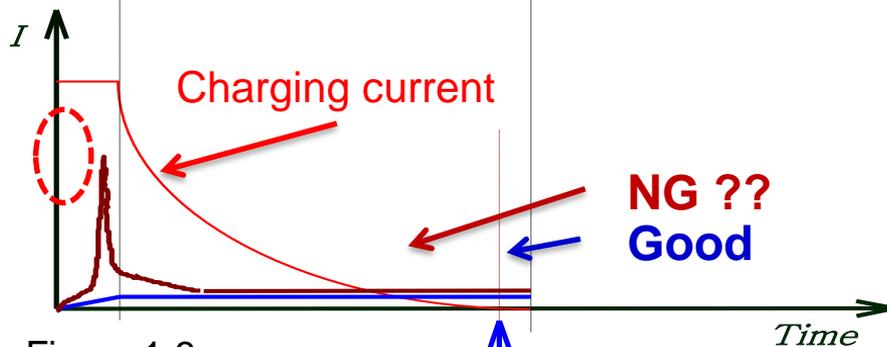
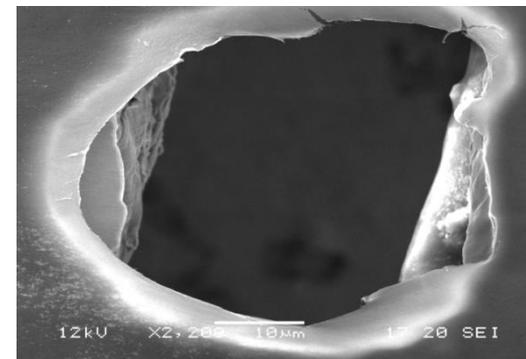
Figure 1-3

Figure1-3 The melted hole caused by a electrical discharge during the regular IR or WV test because of a shorter distance between electrodes. However this defective DUT can easily pass the general regular WV/IR tests and goes to the end users.

From figure 1-3, it is not enough to just measure end leakage current in the WV/IR test. Flashover detection is a must for this issue, the entire testing duration is closely monitored for flashover detection.

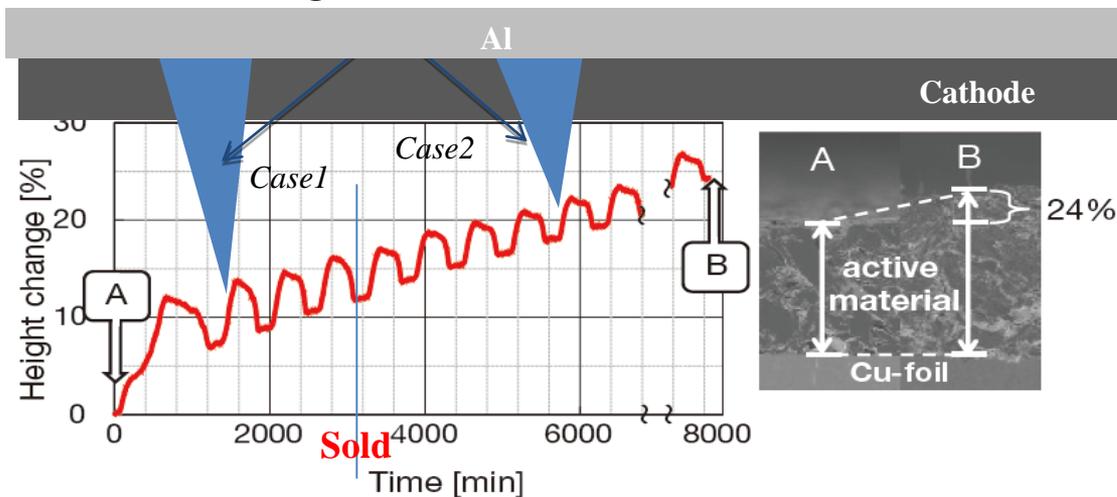
Figure 1-4 Two burrs with different height(length) extruded out from the Al plate

From Figure 1-4, case 1 will cause fire on the 2nd time of charging, **while case 2 will not cause fire in house, and unfortunately, it causes fire after shipping to the customers.** If these burr defects were not detected in the state of dry cell, it will not be detected by general “Rest” method (ΔV) because the distance between electrodes will NOT change while resting.

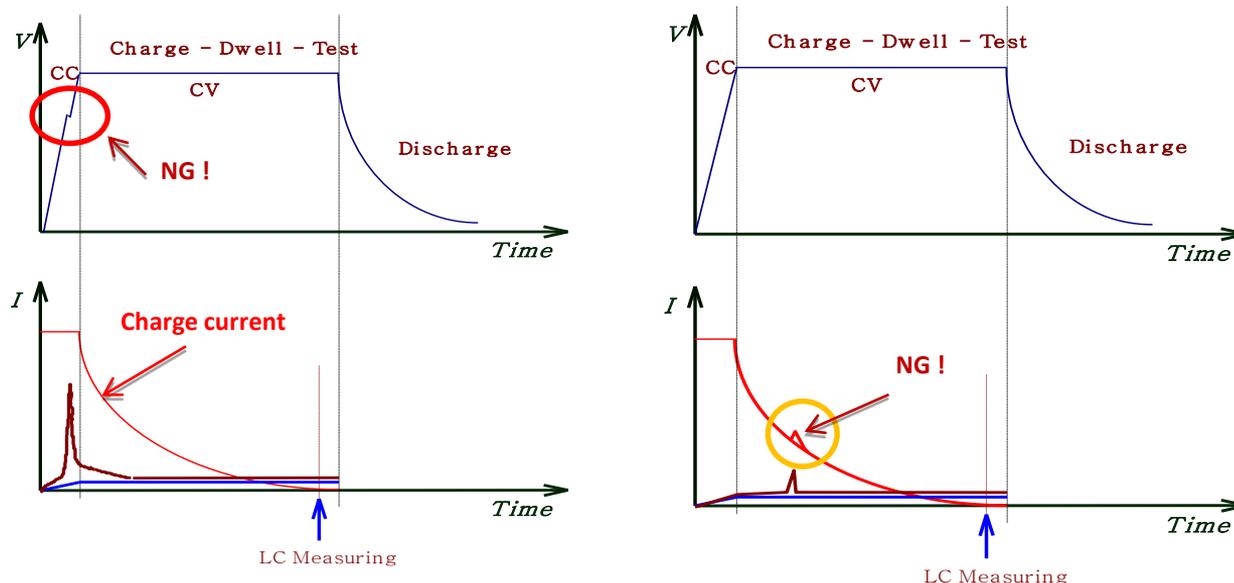
Figure 2-1 Flashover detection is a must for the entire testing duration

Flashover detection for the entire process plus the leakage current monitoring is a sounder test methodology for this issue. Furthermore, the test voltage selection (in according to the thickness of the separator, anode material conditions) and the applying clamping force on the pouch cells while doing this test are also very important.

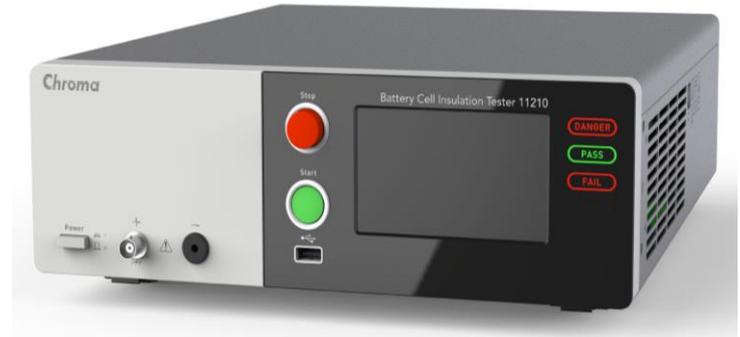
Chroma 11210 Battery Cell Insulation Tester

- Test voltage ~ 1KV
- Programmable charging current: 0~50mA
- High speed measurement: 20mS~
- Contact check (pre-test, post-test or both)
- Fully automatic tests (charging-dwell-measure-discharge) (LC/IR test executed simultaneously with PD detection) .
- PD detection in the entire process[PD Option: Level and Number of each occurrence]
- PD analyzer function[PD Analyzer option : Waveform recording and analysis]

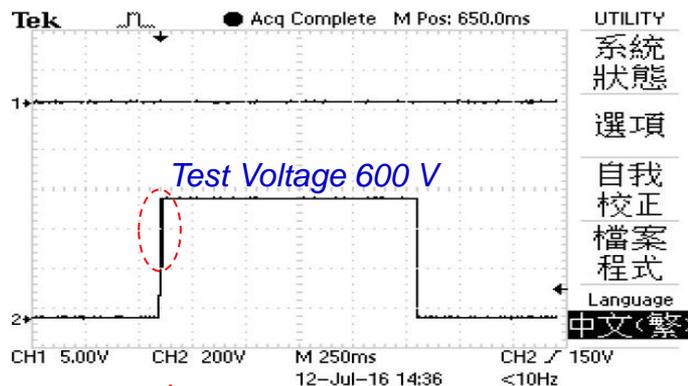
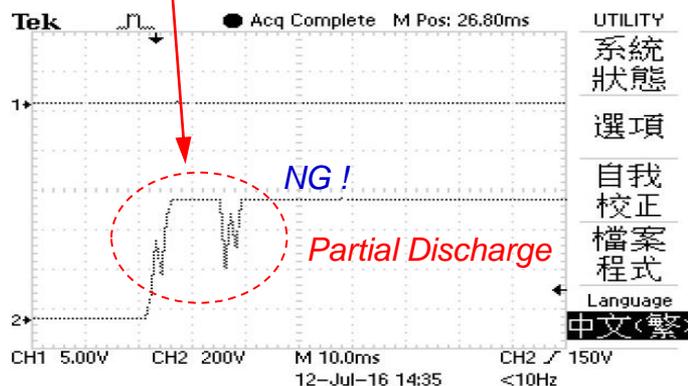
Verification (1): Correlation between PD (flashover) and the melted holes

Analysis on the test voltage waveform and the surface of the separator. Through SEM photos, we confirm that PD did cause melted holes on the separator. The number of the holes and the number of PD is very closely related.

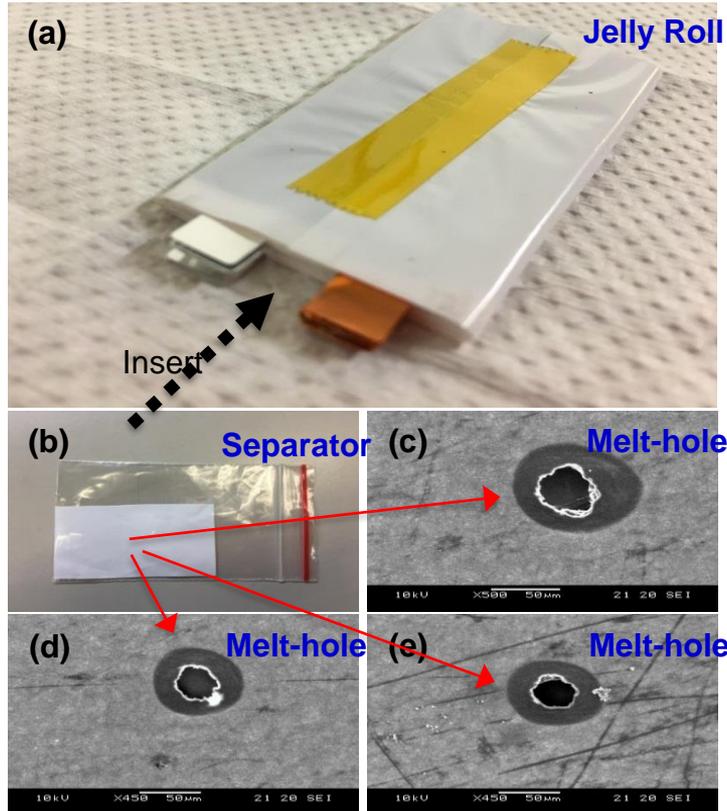
Verification (2): Influence of the separator with melted holes to the LIB cell.

Experiment :

Making holes on the separator intentionally by laser cutting, then make a LIB cell with this separator. Run through charge/discharge cycles and verify the performance of this LIB. Analyze and study the result.

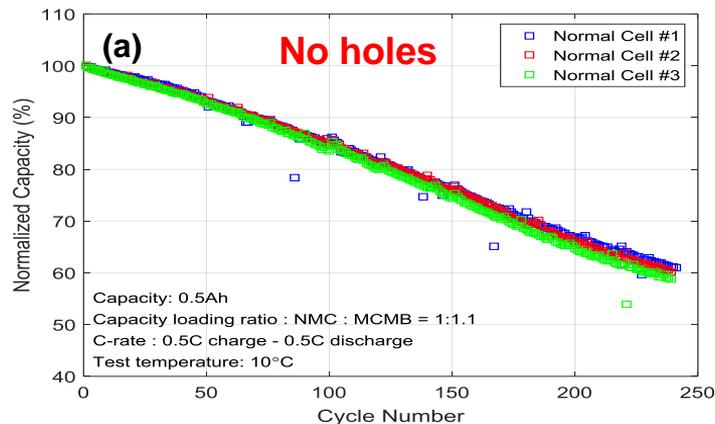
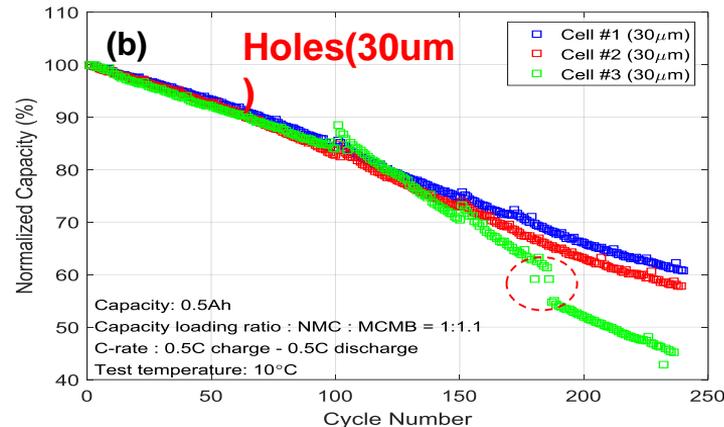
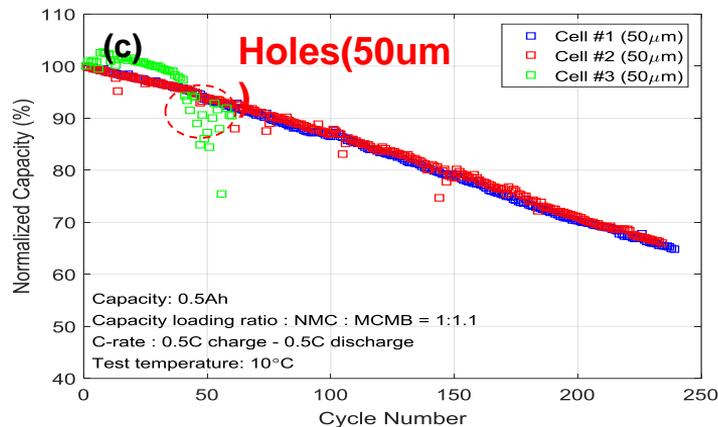
Analyze the changes of those capacities vs. the size of the holes. We observed the **dramatic drop** of the capacity in some specimen.

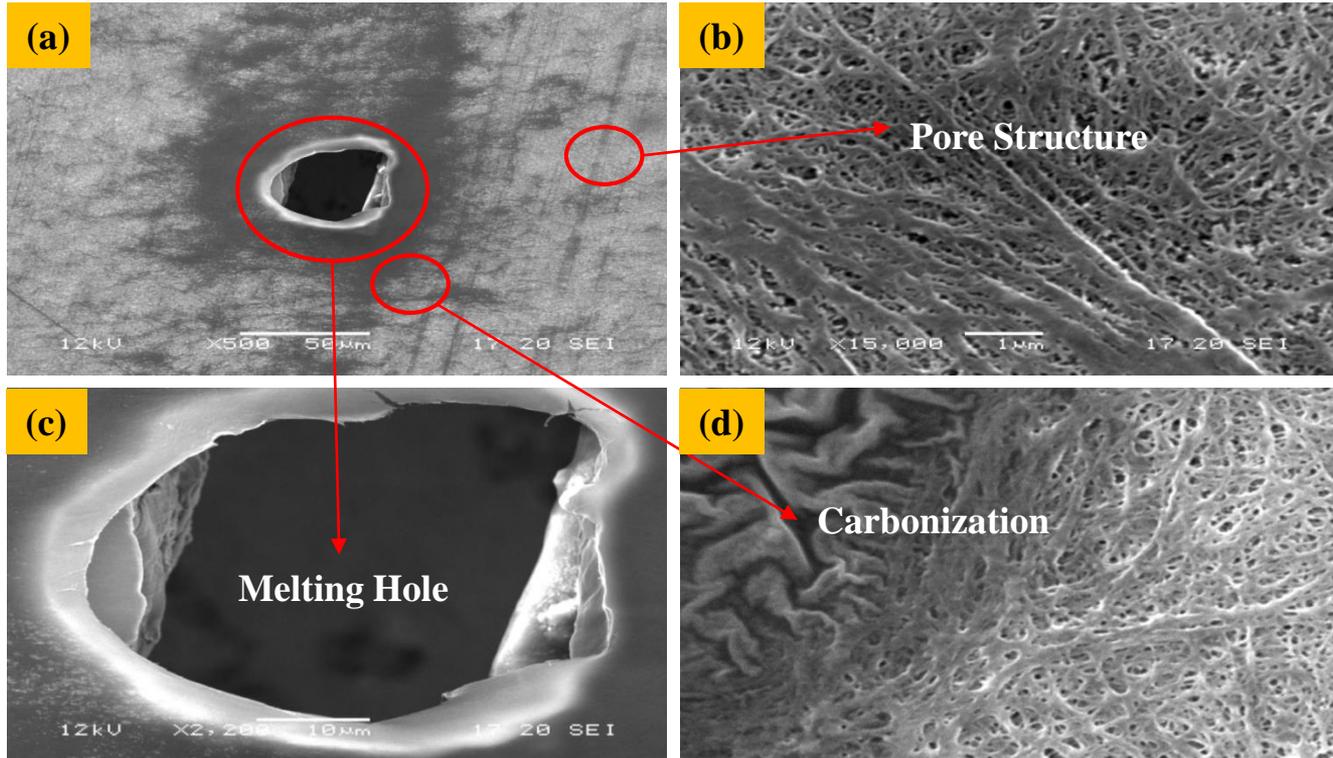
Local Defects on Separator Induced by Flashover

There are black spots or defects due to burning or carbonization can be found on the separator of the jelly rolls when partial discharge being detected during Hi-Pot/IR test.

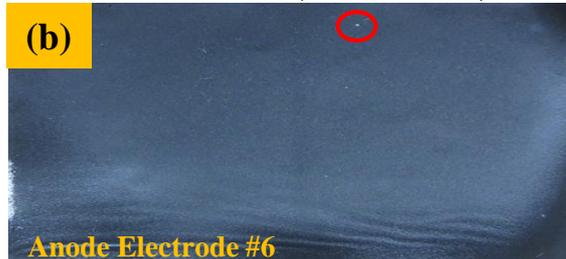
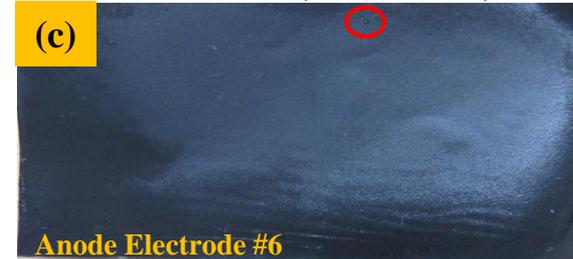
In an argon-filled glove box

After 2 mins (air condition)

After 7 mins (air condition)

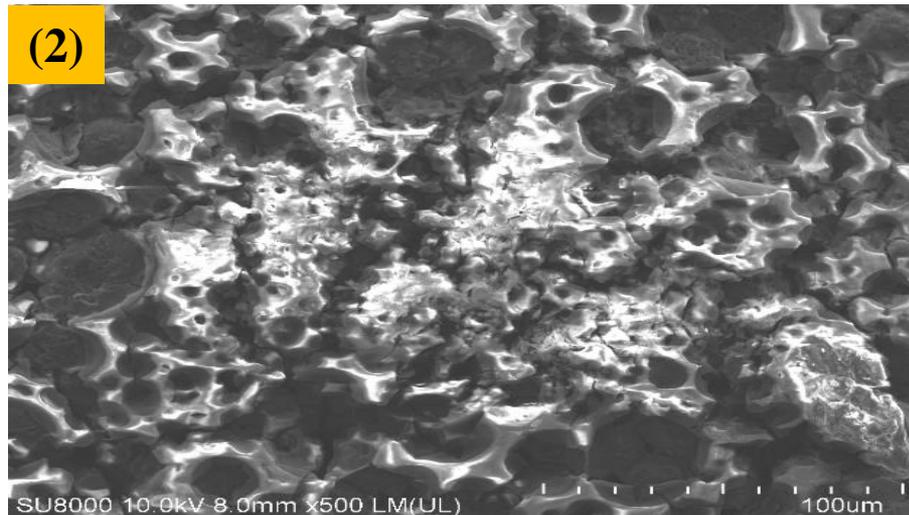
SU8000 10.0kV 8.0mm x500 LM(UL) 100um

White deposits were found with SEM

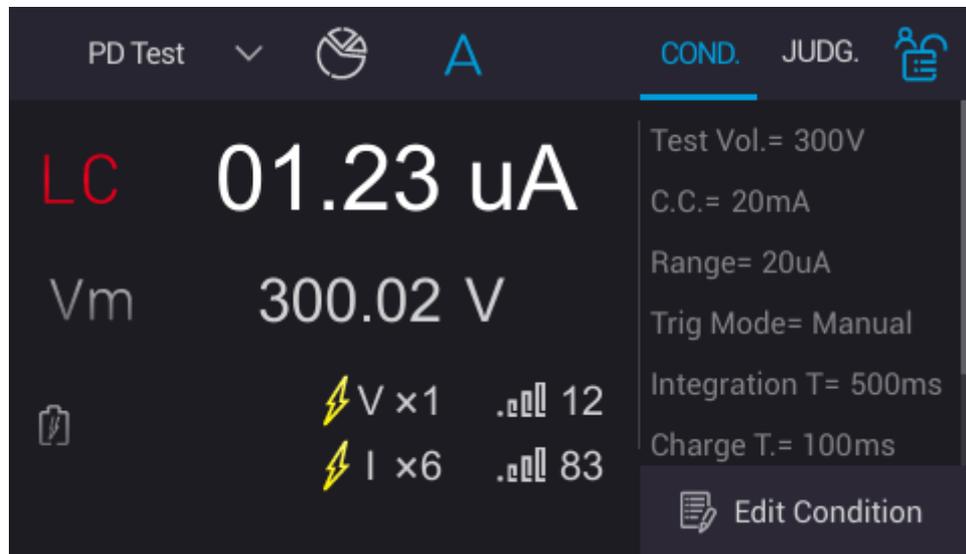
6.1 11210 display

PDV times and level display
PDI times and level display

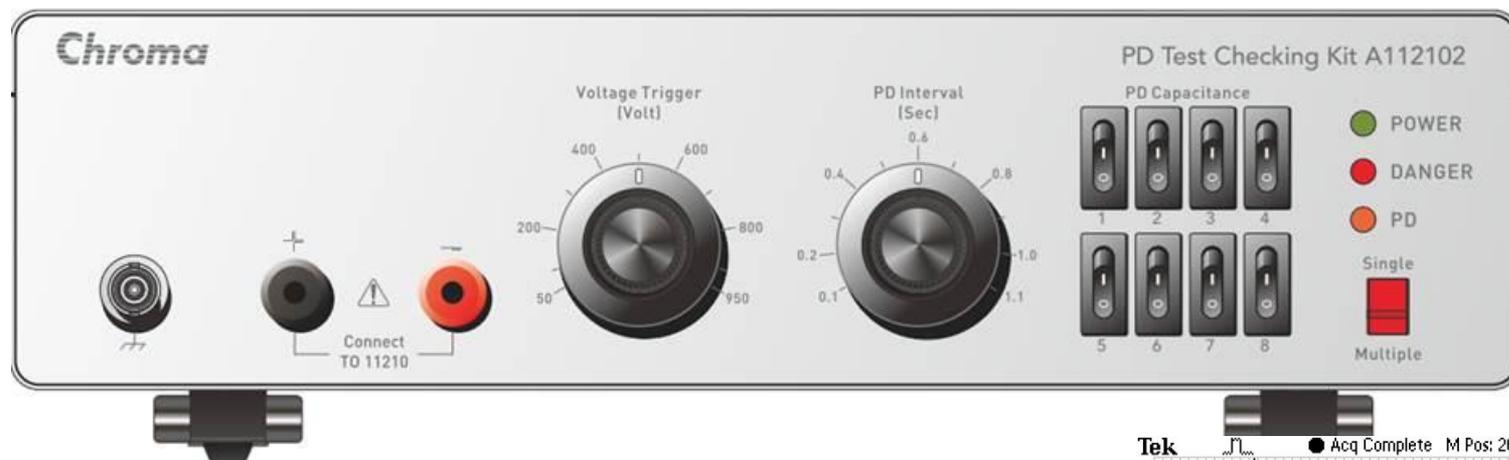
6.2 PD Test Checking Kit Front Panel

Voltage Trigger : PD ignition voltage level setting in CC charge

PD Interval time : Active when Single/Multi SW is switched to “Multi”

PD Capacitance : Select PD “Energy” or “Charge Capacity”

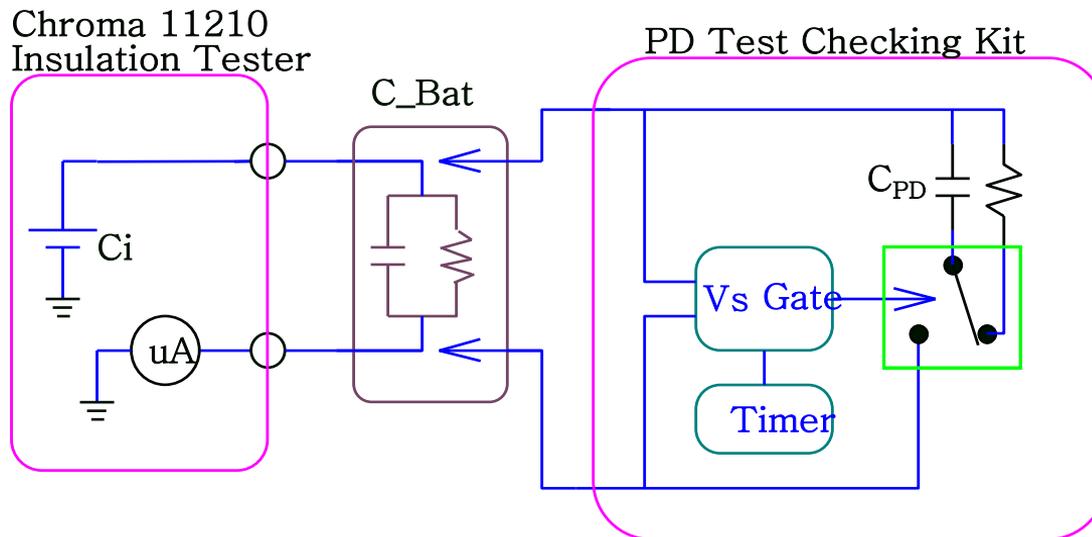
6.2 PD Test Checking Kit Circuit Design

PD energy $\sim \frac{1}{2} C_{PD} V_s^2$;
 V_s : trigger voltage level

PD charge $\sim C_{PD} V_s$

- ➔ Higher C_{PD} selection gets higher PD level reading
- ➔ Higher V_s setting gets higher PD level reading
